Reducing the Frequency of Rear Lamp Breakdown on the DT Coal Hauling Unit Arocs 4845 in the Mining Area of PT. Antareja Mahada Makmur Site PT Mifa Bersaudara Period (2024)

Yato, Muhammad Hanif Iswanto, Tegar Tahanuji, Agus Sutiono, Yuli Adi Gunawan
PT AMM Site Mifa Bersaudara, Indonesia
Email: hanif.iswanto@amm.id, yato@amm.id, tegar.tahanuji@amm.id

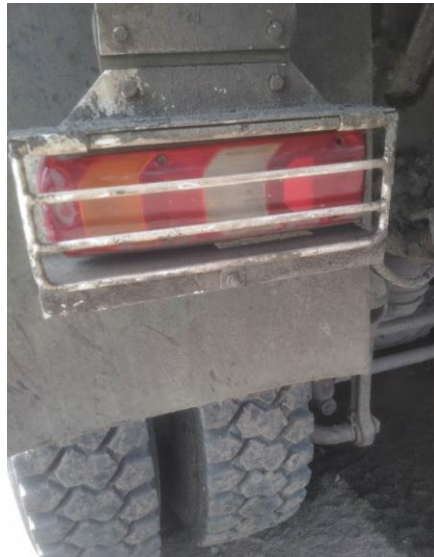
Figure 1. Rear Lamp of a Mercedes-Benz Arocs 4845

The authors' research concept involved direct experimental implementation to reduce the frequency of breakdowns caused by dead rear lamps. We identified several issues as contributing to the failure of the rear lamps. One was the poor quality of the previous bulb-type rear lamps, which frequently broke when subjected to vibrations. Therefore, we replaced the bulb-type rear lamps with better-quality LED ones.

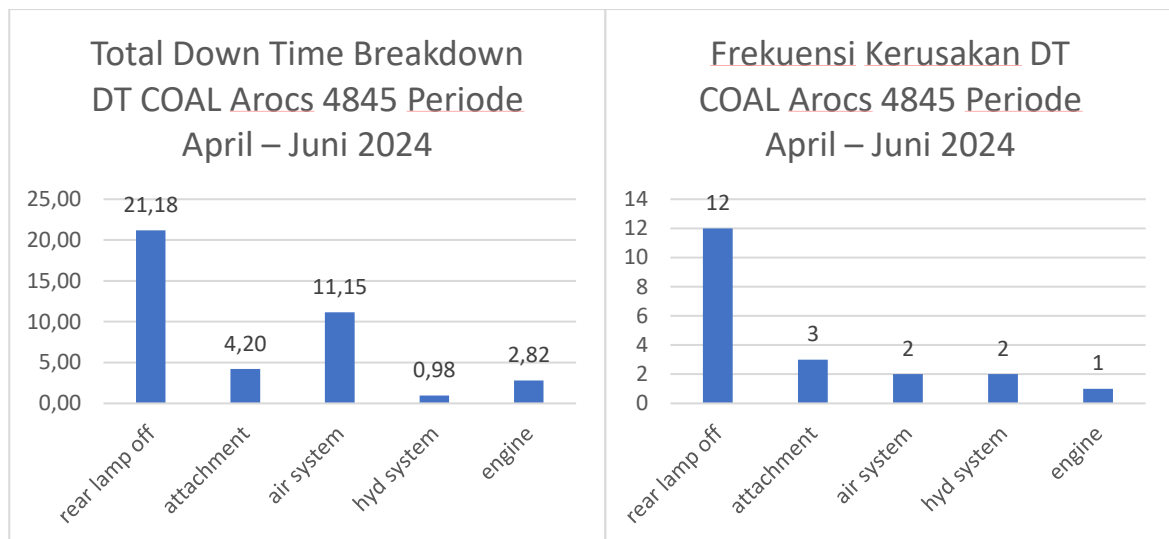
Figure 1. Pareto Achievement of Rear Lamp Breakdown Duration & Frequency (before Improvement)

In April 2024, the Arocs 4845 experienced 12 rear lamp breakdowns, with a total lost time of 21.18 hours, as shown in Figure 3. Therefore, focused improvements were required to address this issue.

1. Changing the rear lamp type from bulb to LED.
2. Installing rubber on the rear lamp bracket to dampen vibrations/shocks.
3. Modifying the rear lamp bracket by adding a chain to protect it in case the rubber breaks/damages.
4. Replacing the bracket mounting bolts from 12mm to 14mm to strengthen the rear lamp mounting bracket.

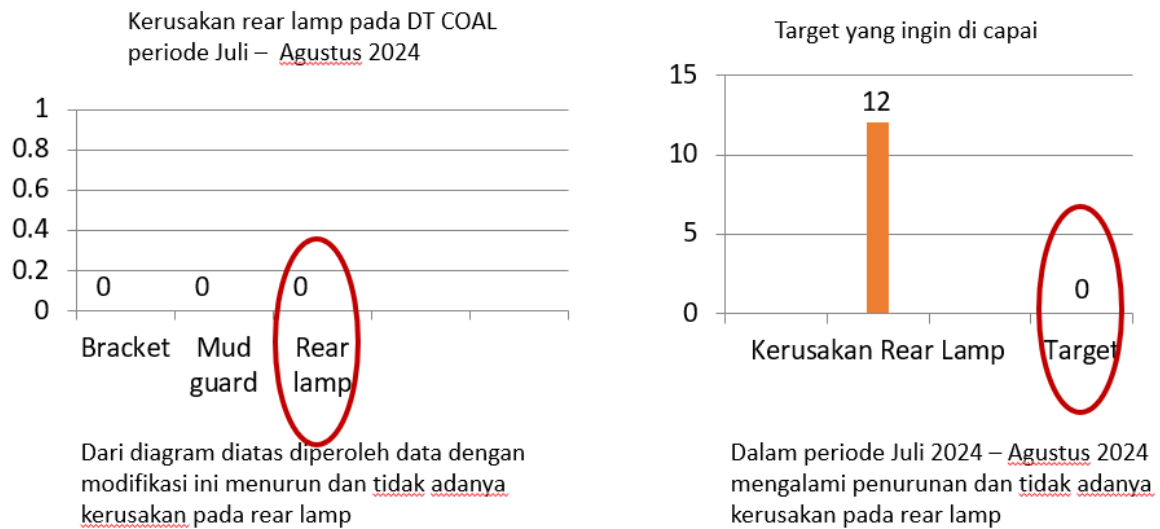
Figure 2. Breakdown Frequency Table, July 2024 (after modification)

The innovation results show that the implementation reduced breakdowns in both duration and frequency. After the July 2024 improvements, the frequency of rear lamp breakdowns even disappeared. The results of this study indicate that the implementation of replacing bulb-type rear lamps with LED ones and modifying the rear lamp brackets in the mining environment of PT Antareja Mahada Makmur, PT MIFA Bersaudara's jobsite, was very effective in reducing rear lamp breakdowns and increasing the productivity of the Mercedes-Benz Arocs 4845 unit in coal gathering and hulling activities.
