## Assessment of Urban Heritage Potential and Flood Resilience in the Colonial Tourism Area of Cirebon City: A Case Study of Lemahwungkuk Subdistrict

Cirebon, a coastal city with rich colonial heritage, lacks specific regional regulations for managing strategic heritage areas, making them vulnerable to development and floods. There is no Regional Regulation that specifically regulates the management of strategic areas of cultural heritage, especially colonial heritage. The absence of this regulation makes colonial heritage areas less targeted and vulnerable to damage from development and disasters, such as floods. This study focuses on how to identify the potential of colonial heritage areas for tourism activities in *Lemahwungku* District, Cirebon City, and support tourism that is *resilient* to flood disasters. With a *mixed-methods* approach, the analysis method used is a descriptive statistical method by presenting the results of building observation identification using *spider web* graphs, then a flood potential modeling analysis is carried out using geospatial analysis to produce a map of flood vulnerability levels. Then the two processes are triangulated through interviews

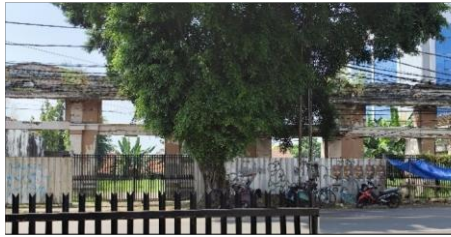
Image: Physical aspects of the building – walls and foundation of the K.PM Agency building

The colonial heritage buildings that have physical aspects such as roofs, walls, and foundations have been damaged materially. The preservation of cultural heritage buildings faces various obstacles, especially in terms of overlapping ownership, complicated and expensive repair processes, and limited government budgets. The lack of coordination between the owners, as well as the low awareness of the importance of preservation, has led to many buildings being abandoned and left in disrepair. In some cases, buildings have even been removed from cultural heritage status after being severely damaged, showing the weakness of the existing protection system. Difficulties in the coordination and leasing process resulted in the building being left in a state of disrepair. In addition, many other heritage buildings are neglected due to the time-consuming and expensive repair process, while the government can only allocate a budget for the repair of one building. This situation was further exacerbated by the owner's desire to completely overhaul the cultural heritage building, which caused the building to be left in ruin. In the end, if the cultural heritage building is not maintained and loses its traces, there will be a need to remove its status as a cultural heritage.

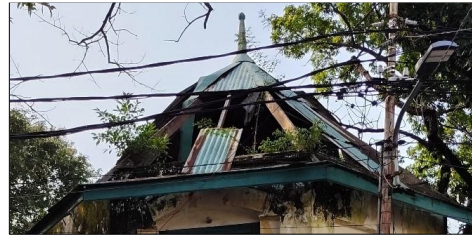
Image: Physical aspects of the building – roof Gedung bunder kebumen Building, Kebumen

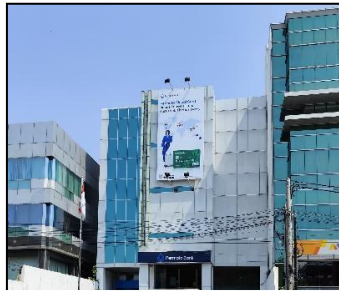
Image: modern banking building

However, based on the map of Leiden University, which was initially a colonial heritage building, there are findings that some have completely changed into modern buildings, but the plots have not changed. Changes to historic buildings have occurred many times because, during their construction, there were no special rules governing their preservation, coupled with weak law enforcement and a lack of public awareness. The regulations on cultural heritage only came into force in 1992 and were updated into law in 2010, but their application has not been evenly distributed in various regions. In Cirebon, for example, the determination through the Mayor's Decree only began in 2001 and has not been fully used as a reference. In addition, the preservation process is often hampered by high costs and the need to use special materials that cannot be replaced carelessly because they have been regulated in the preservation provisions. So, the authenticity of the colonial heritage building has been determined in the Mayor's Decree, then the building that has been determined must follow the technical in maintaining the cultural heritage building, there must be a feasibility study not to be used as a new function, the feasibility can be from the feasibility of the structure, the feasibility of the function, or in terms of architecture because there must be an adaptation so adapt from the form, The style for adaptation, for example, must replace some elements of the building is allowed or not because when revitalizing the cultural heritage building, we must pay attention to the aspects of authenticity, so that there are not so many changes, it ends up eliminating the authenticity of the building, so the principle is prudence and maintaining the authenticity of the building.

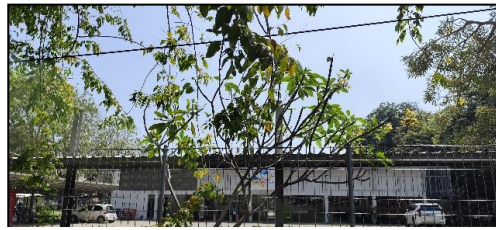
Image: Mandiri livin park modern building

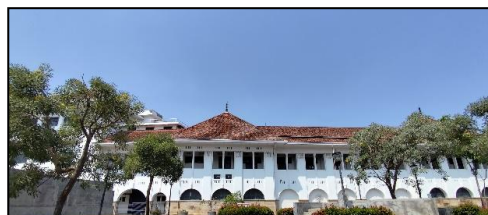
Image: private ownership aspect (BAT Building)

In the aspect of ownership, it has a score of 75, the lowest criterion among other elements, because of the many ownership statuses of the building, most of which are private and privately owned. Most historical buildings are owned by individuals because they belong to families or individuals from the beginning, then are inherited or sold to others. Due to limited funds, the government was unable to acquire and maintain all of these buildings, so the responsibility for maintenance fell more into the hands of private owners. Thus, the Government or public institutions do not have adequate funds to buy and maintain all these buildings. As a result, the maintenance of heritage buildings is often the responsibility of private owners, which can have an impact on the condition and sustainability of the building.

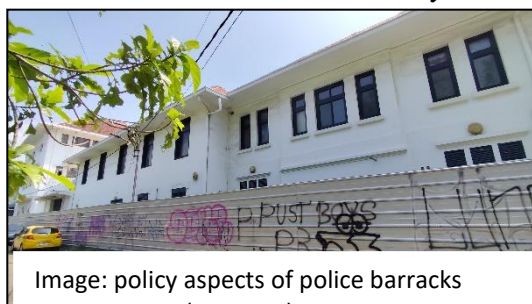
Image: policy aspects of police barracks management (rear BAT)

The management policy aspect has a score of 167, which is the highest score of the other elements. Buildings that have been designated as cultural heritage through the Mayor's Decree cannot be changed arbitrarily, because there are binding legal rules. The regulation is listed in the 2010 Law on Cultural Heritage and is further regulated technically in PUPR Regulation Number 19 of 2021 concerning the preservation of historic buildings. Thus, buildings that have been stipulated in the Mayor's Decree should not be changed carelessly, because there are policies regulated in the 2010 law and Public Works Government Regulation No. 19 of 2021, which governs the preservation of cultural heritage. This policy must be followed to maintain the authenticity and integrity of the building.

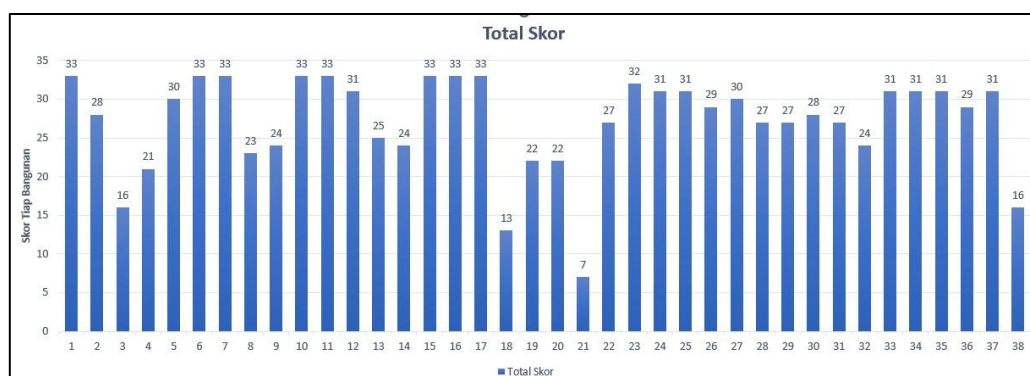
After creating a spider web to assess a total of 38 heritage buildings from 7 aspects, a bar chart is made to determine which buildings have an above-average value. The average score obtained is 27; there are several buildings with the highest score of 33, while the lowest score is 7 in building number 21. The building assessment can be seen in the picture below.

Figure 4. Bar chart analysis results

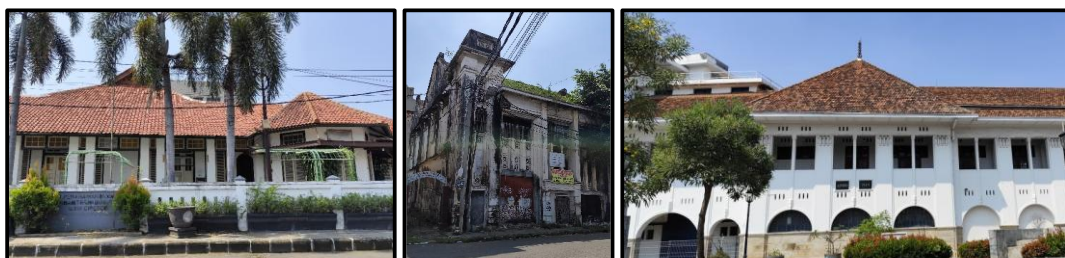
Waterlogging in the Cirebon heritage area generally occurs due to high rainfall for approximately three hours, but the impact is limited, and the water usually recedes quickly. The lack of special precautions and the lack of reports from the owners of cultural heritage buildings are obstacles to handling them. Therefore, it is essential to collaborate with the Culture and Tourism Office to unite heritage building data to support more targeted and efficient flood management. Thus, the occurrence of flooding in the Cirebon colonial heritage area was caused by the high volume of water and rain that lasted about 3 hours. Inundation usually occurs in the Investment Office area and will recede in about 1 hour. The lack of preventive measures and the absence of reports from the owners of cultural heritage buildings have made flood management less than optimal. Therefore, synergy is needed between cultural heritage owners and the Cirebon City Culture and Tourism Office to integrate heritage data to strengthen flood mitigation efforts in the area.

Image: The location of the Cultural Heritage building where inundation often occurs
