## Structural Analysis of the Pasar Minggu Subdistrict Health Center Building in South Jakarta City

**Ahmad Difky Nur Fathoni, Syahrul UIIa AI Muarif, Tira Roesdiana**

Universitas Swadaya Gunung Jati, Cirebon, Indonesia

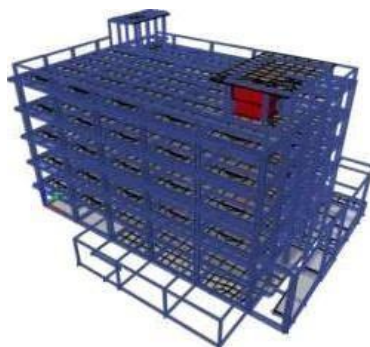
**Figure 1: ETABS-Based Structural Modeling**

For the purpose of conducting a detailed structural assessment of the Pasar Minggu Subdistrict Health Center building in South Jakarta, ETABS version 18.1.1 was employed to construct a three-dimensional structural representation and to evaluate the internal forces generated by the defined load combinations.

Structural system modeling in the ETABS software is developed in accordance with applicable design standards and configured to closely represent the actual building conditions. This approach is intended to ensure accurate evaluation of the structural performance under the prescribed loading conditions.
